SAYANO SHUSHENSKAYA 2009 ACCIDENT UPDATE

BY FRANK A. HAMILL

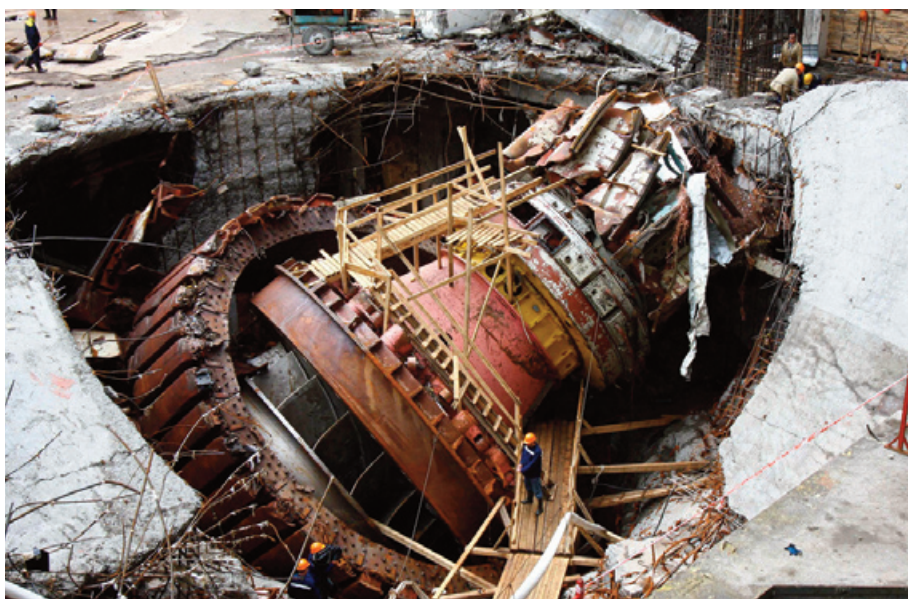
Figure 2. Part of the damage to the powerhouse after the 17 August 2009 accident. Unit 2 as seen on 3 September 2009 after dewatering.

At 08:13 and 25 seconds on the morning of 17 August 2009, Unit 2 in the plant suffered a total load rejection. This was followed by a violent eruption of water in the draft tube lifting the turbine head cover, turbine runner, shaft, turbine and generator bearings upward several meters (a witness estimated three meters rise). This destroyed the generator rotor spider and permitted water to flood the

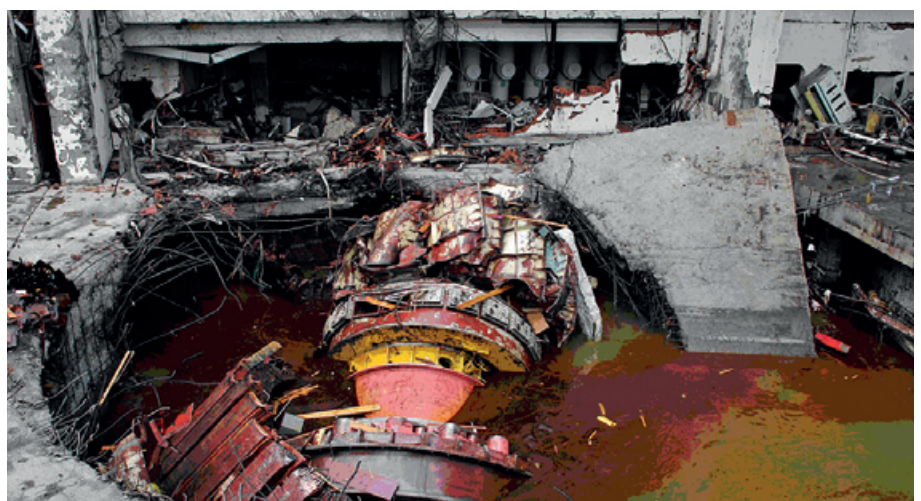
turbine pit and spill out into the powerhouse operating floor (Figure 5). The sudden failure of Unit 2 was followed immediately by similar failures of Units 7 and 9. In all, nine of the ten operating units were either destroyed or severely damaged. Only Unit 6, which was out of service at the time, was spared from severe damage, although it was flooded by water from the other failed units. In all, 75 people died and 13 were injured in the powerhouse as a result of the flooding, which raised the event to the level of a national scale disaster.

Figure 5. Unit 2 several hours after failure.
